Intel[®] Mobile Pentium[®] III Processor Specification Update

Release Date: October 2000

Order Number: 245306-012

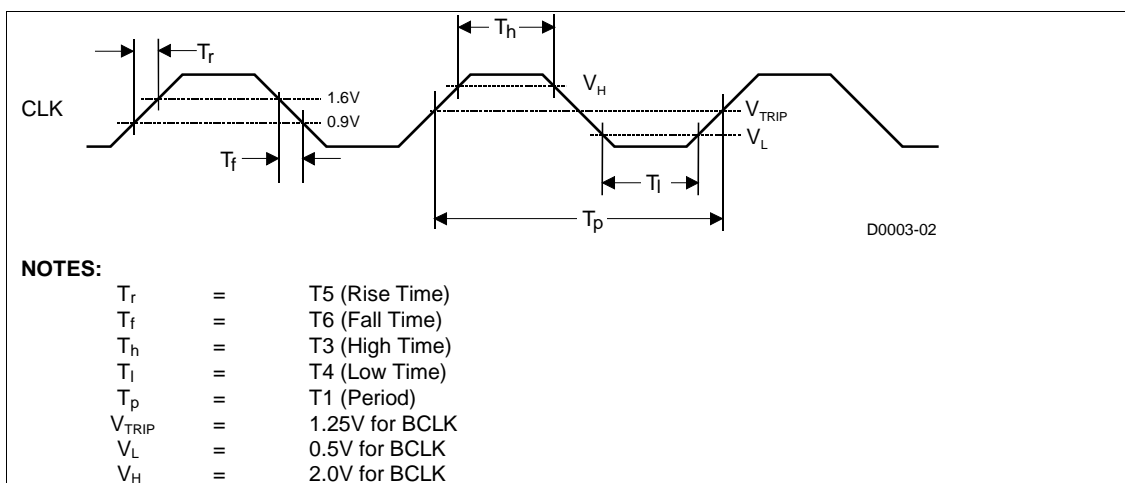
Figure 7. BCLK Timing Waveform

Symbol	Parameter	Min	Typ	Max	Unit	Figure	Notes
	System Bus Frequency		100		MHz		
T1	BCLK Period		10		ns	Figure 7	Note 2
T2	BCLK Period Stability			± 250	ps		Notes 3, 4
T3	BCLK High Time	2.70			ns	Figure 7	at >2.0V
T4	BCLK Low Time	2.45			ns	Figure 7	at <0.5V
T5	BCLK Rise Time	0.175		0.875	ns	Figure 7	(0.9V – 1.6V)
T6	BCLK Fall Time	0.175		0.875	ns	Figure 7	(1.6V – 0.9V)

1. All AC timings for GTL+ and CMOS signals are referenced to the BCLK rising edge at 1.25V. All CMOS signals are referenced at 0.75V.
2. The BCLK period allows a +0.5 ns tolerance for clock driver variation.
3. Not 100% tested. Specified by design/characterization.
4. Measured on the rising edge of adjacent BCLKs at 1.25V. The jitter present must be accounted for as a component of BCLK skew between devices.

For B0 step processors, the $V_{IH,BCLK}$ Min spec is changed to 2.0V (from 1.7V for A2 step) and $V_{IL,BCLK}$ Max spec is changed to 0.5V (from 0.7V for A2 step). Due to this, new values are specified for BCLK high and low times for B0 step processors. These modifications affect corresponding specs in Table 13, Table 14, Table 24, and Figure 7 in *Mobile Pentium® III Processor in BGA2 and Micro-PGA2 Packages datasheet* (Order Number 245302-002).
